Manhole Inspection Summary

Manhole # S09A1_001MH

Insp Date: **5/14/08 9:12 AM**

Location Address: **3635 Benson Av**

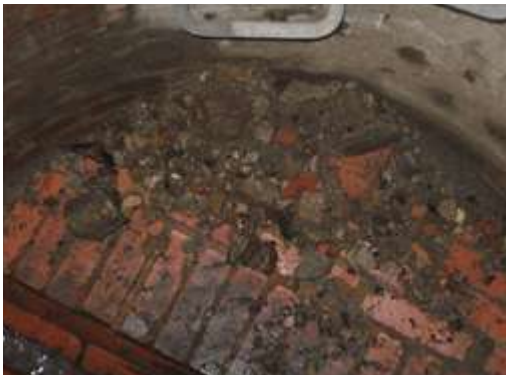
Misc

debris on bench

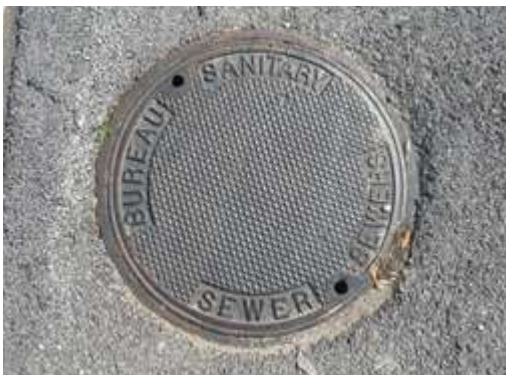
Additional Top View

lid pic

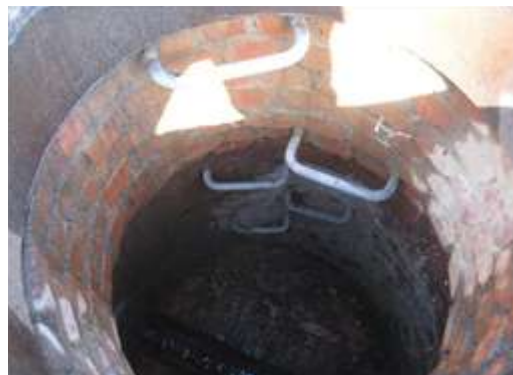
Defect 5

Frame infiltration large picture

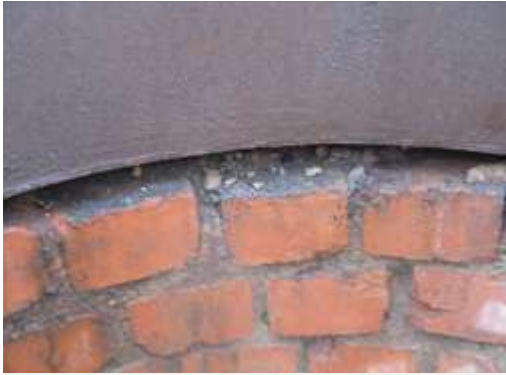
Defect 2

signs of infiltration from frame-chimney connect

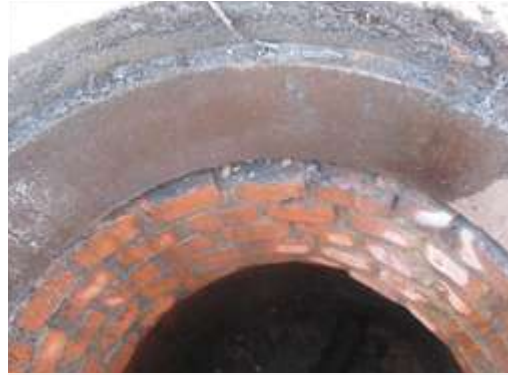
Defect 1

infiltration from lid frame connect as well as from slope of manhole.

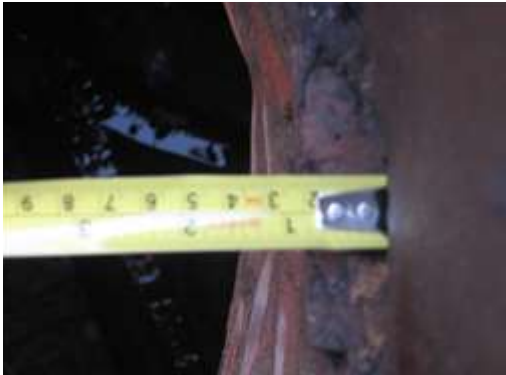
Defect 4

offset = 1.25

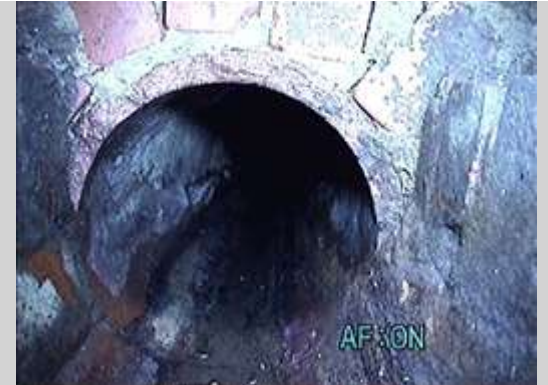
12 O'Clock Outflow

8 in. Circular Gravity Sewer
Pipe Out @ 12 O'Clock

Pipe Height: **8.4** (in.) Rod and Bar (Angled)
Pipe Material: **Clay** ☐ Pipe Lined
Invert Depth: **8.42** (ft.) Flow Characteristics: **Slow**
Deposits: ☒ None ☐ Mud ☐ Sludge ☐ Debris ☐ Grease
Silt Depth: **0** (in.) Deposits Extent:
Infiltration: **None** Pipe Seal Cond: **Sound**

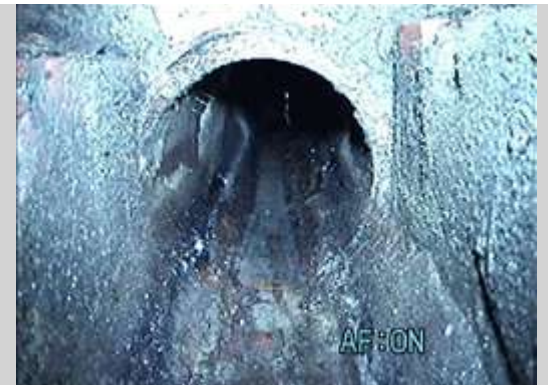
3 O'Clock Inflow

6 in. Circular Gravity Sewer
Pipe In @ 3 O'Clock

Pipe Height: **6** (in.) Rod and Bar (Angled)
Pipe Material: **Clay** ☐ Pipe Lined
Invert Depth: **8.25** (ft.) Flow Characteristics: **Slow**
Deposits: ☒ None ☐ Mud ☐ Sludge ☐ Debris ☐ Grease
Silt Depth: **0** (in.) Deposits Extent:
Infiltration: **None** Pipe Seal Cond: **Sound**

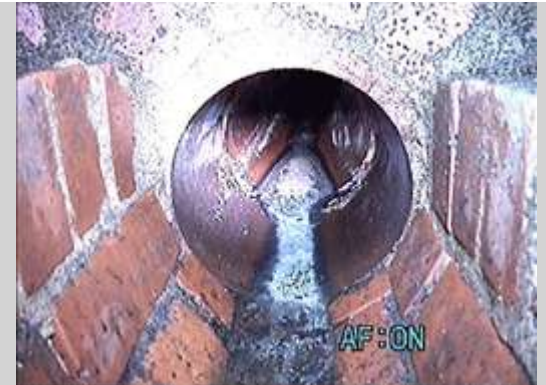
6 O'Clock Inflow

8 in. Circular Gravity Sewer

Pipe In @ 6 O'Clock

Infiltration: **None** Pipe Seal Cond: **Sound**
